Breakout Session Track 2: Structural Inspection

Structure Inspections Utilizing UAS

Improving Quality of Bridge Inspections Using Unmanned Aircraft Systems (UAS)

U s e o f U A S i n B r i d g e I n s p e c t i o n

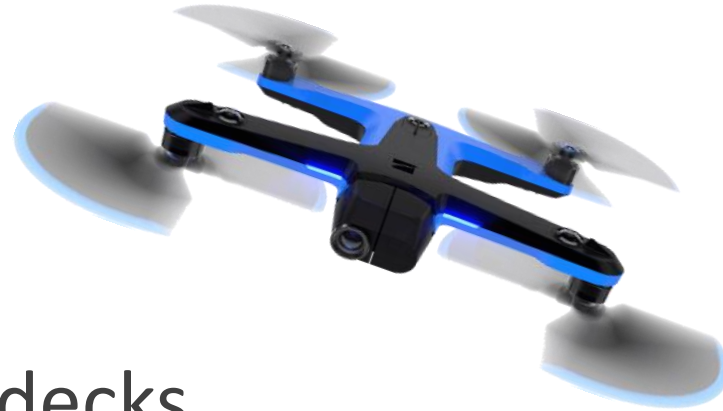
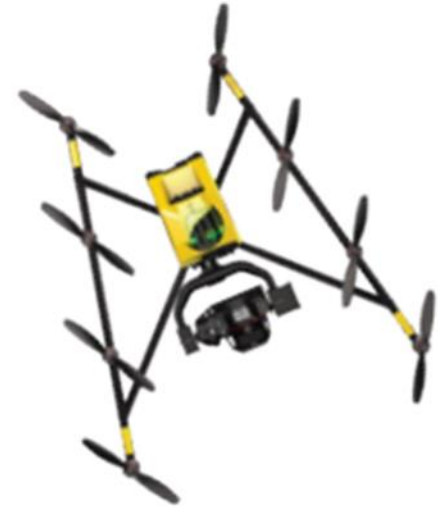
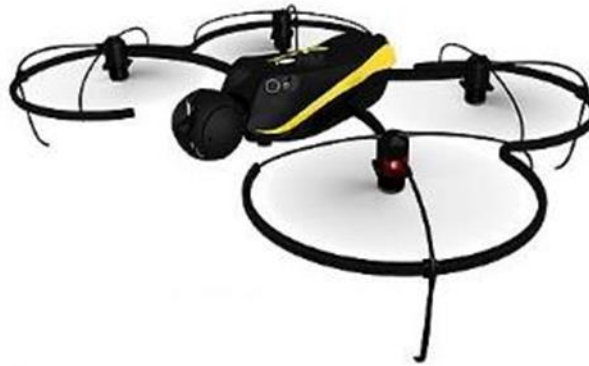
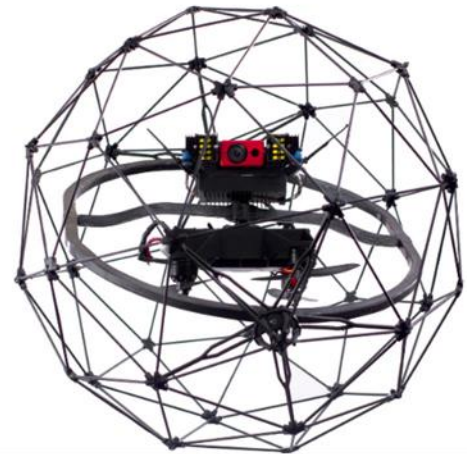
Assessment of UAS Technology

- Inspection-specific UAS
- Object Sensing
- Capable of looking up
- Fly without GPS, under bridge decks
- Photo, Video and Thermal Imaging
- Confined Space

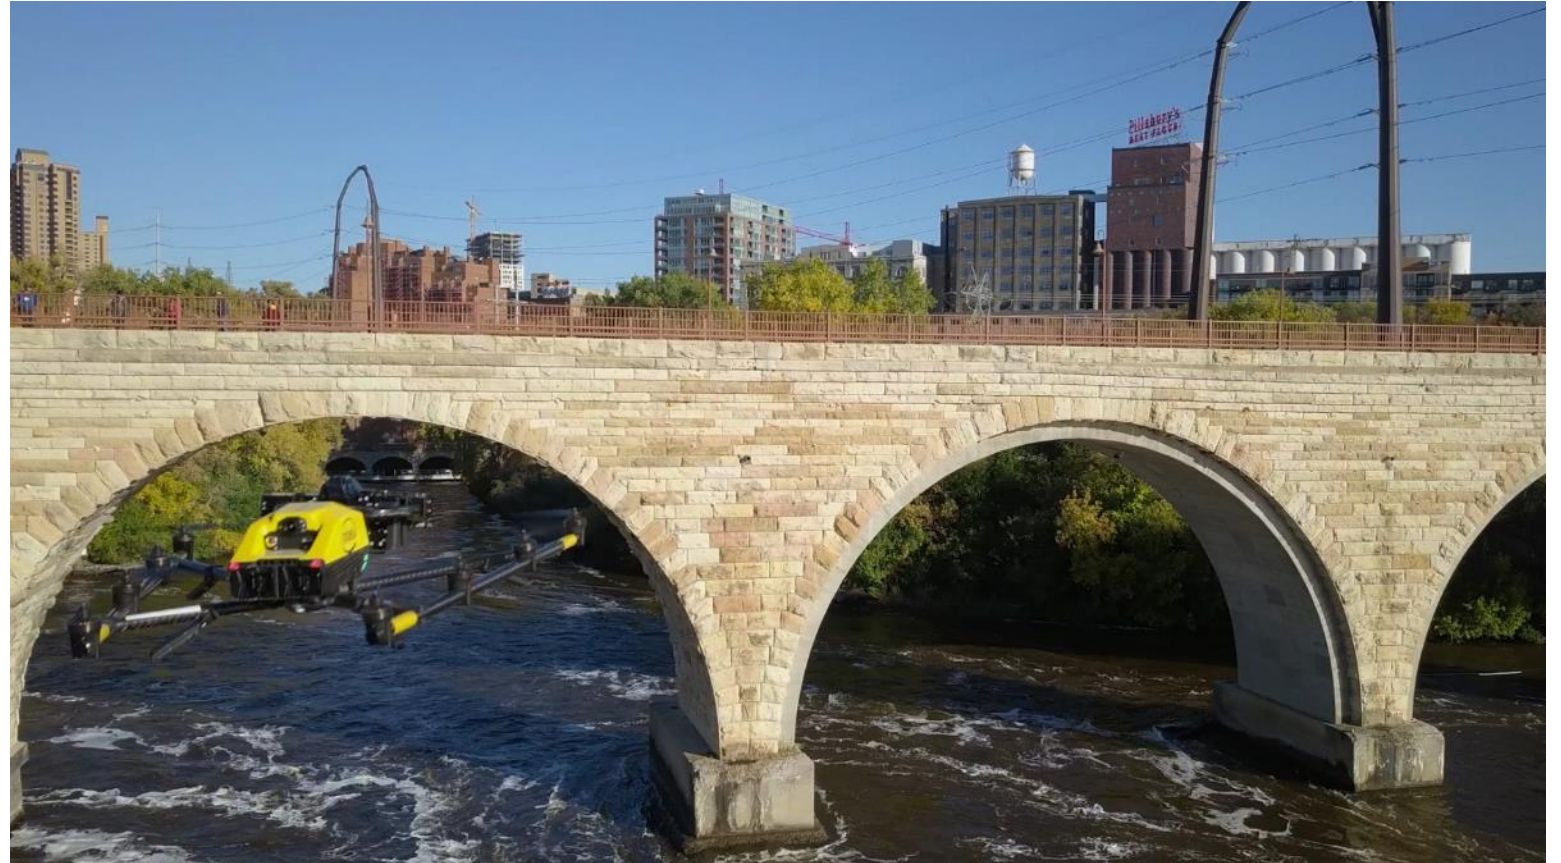
Commercial Drones (\$20,000 - \$35,000)

- Intel Falcon 8+
- DJI Matrice 210
- Flyability Elios

- Sensor Size
- Reliability
 - Dual Batteries
- Durability
- Purpose Built for Inspection

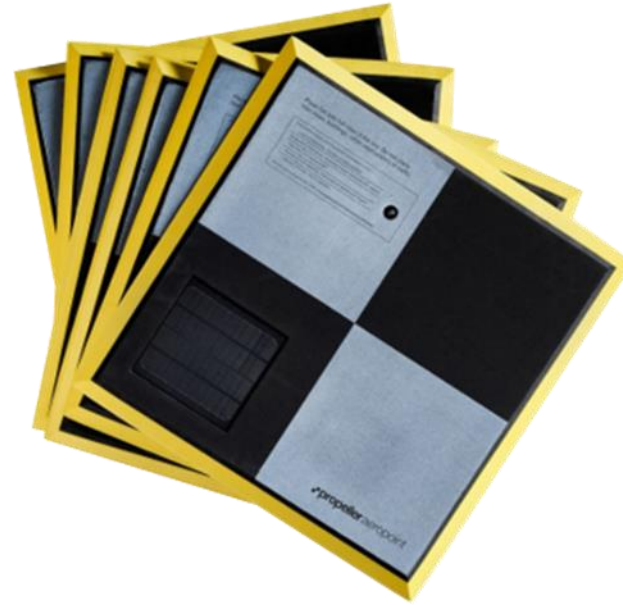
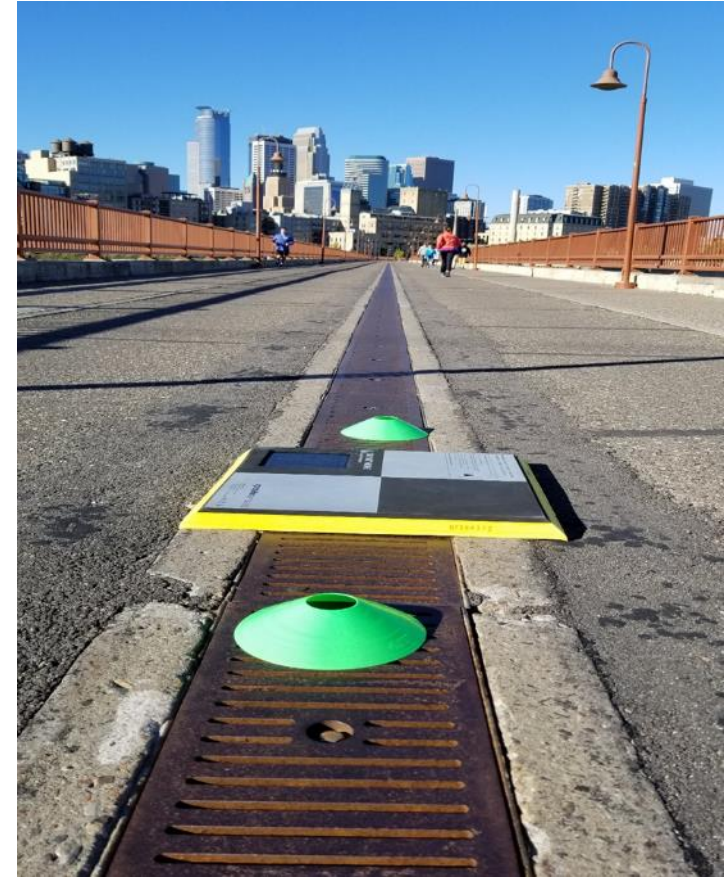
Propeller Aeropoints

- Automatic Ground Control Points
- Provides precision ground control
- Adds ability to accurately geolocate assets and inspection results

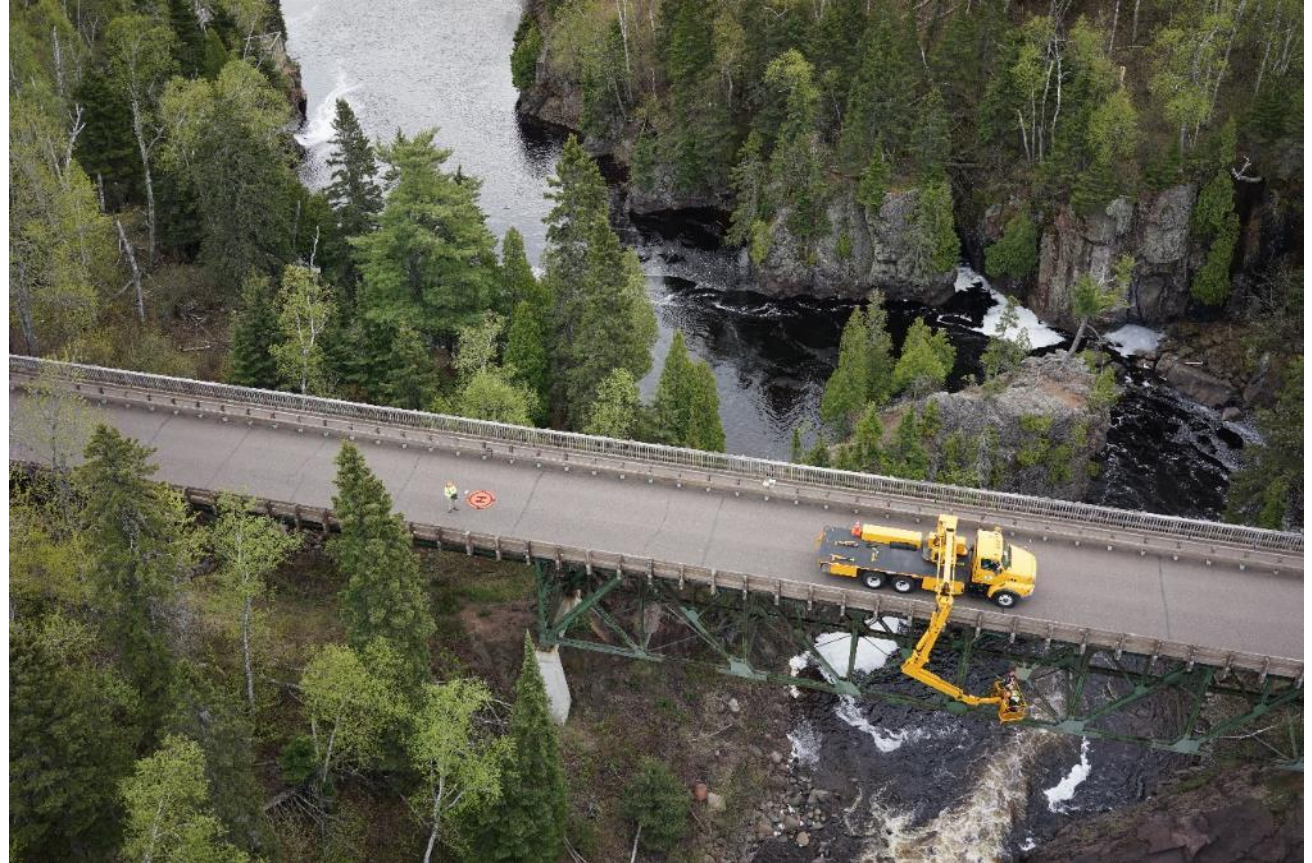
2. Detection of Defects and Deficiencies

- Use UAS as an access tool
- Traditional Access Tools
 - Aerial Work Platforms (AWP's)
 - Rope Access and Structure Climbing
 - Ladders
 - Binoculars

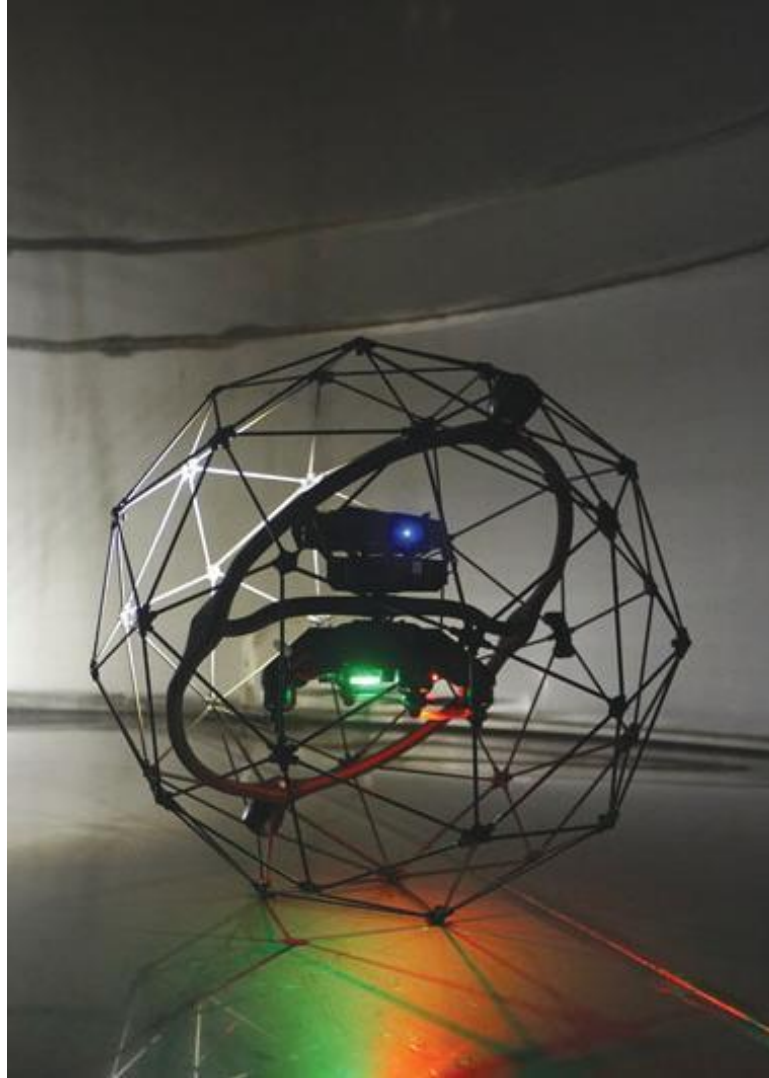
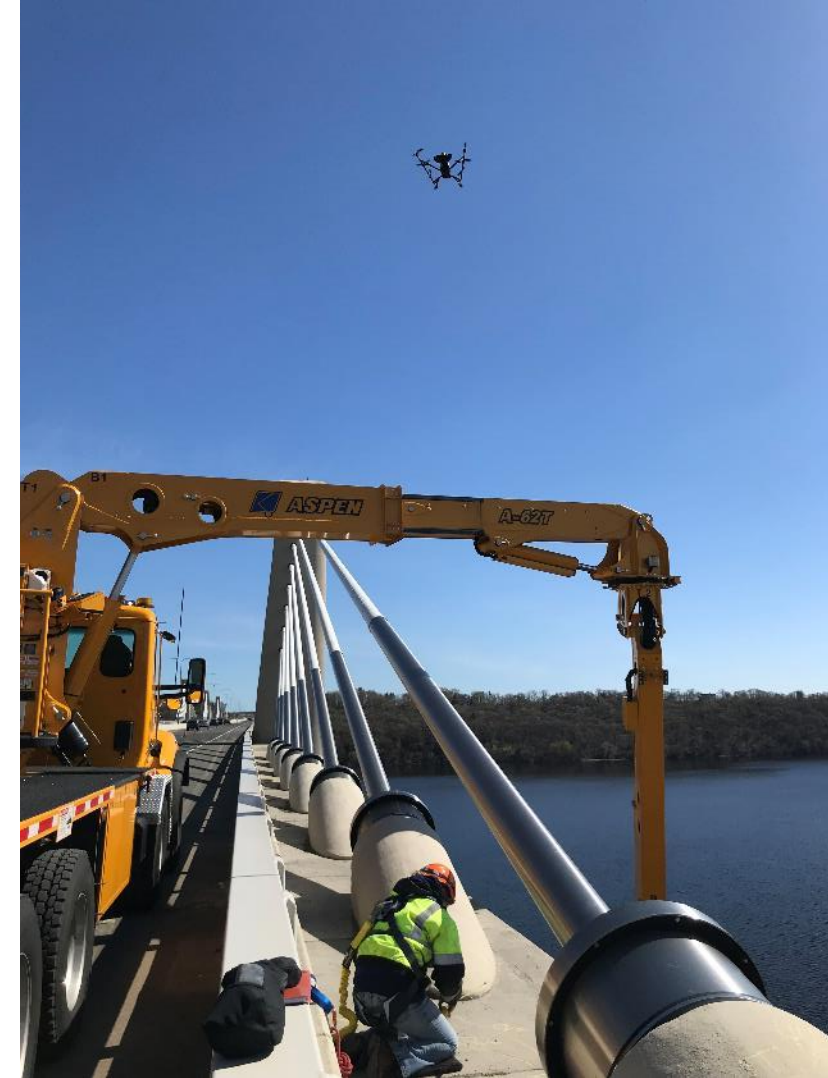
3. Document Conditions and Deficiencies

Deliverables – Orthomosaic

The screenshot displays a software interface for documenting bridge conditions using an orthomosaic. The main map view shows a bridge deck with various annotations, including lines and polygons, labeled with measurements in feet and inches. The left sidebar contains a 'Layers' panel with a search filter and a list of layers: 'Annotations 2', 'Element 300', 'Line 181', 'East Joint', 'Pier 15A Joint', 'Joint Filled with Debris', 'Delamination', and several 'Polygon' layers. The right sidebar shows an 'Inspection' panel with a search filter, a list of inspection points, and a 'SAVE INSPECTION AS ANNOTATION' button. The bottom right corner displays coordinates: 44.97134° N 93.29724° W and Elevation: -.

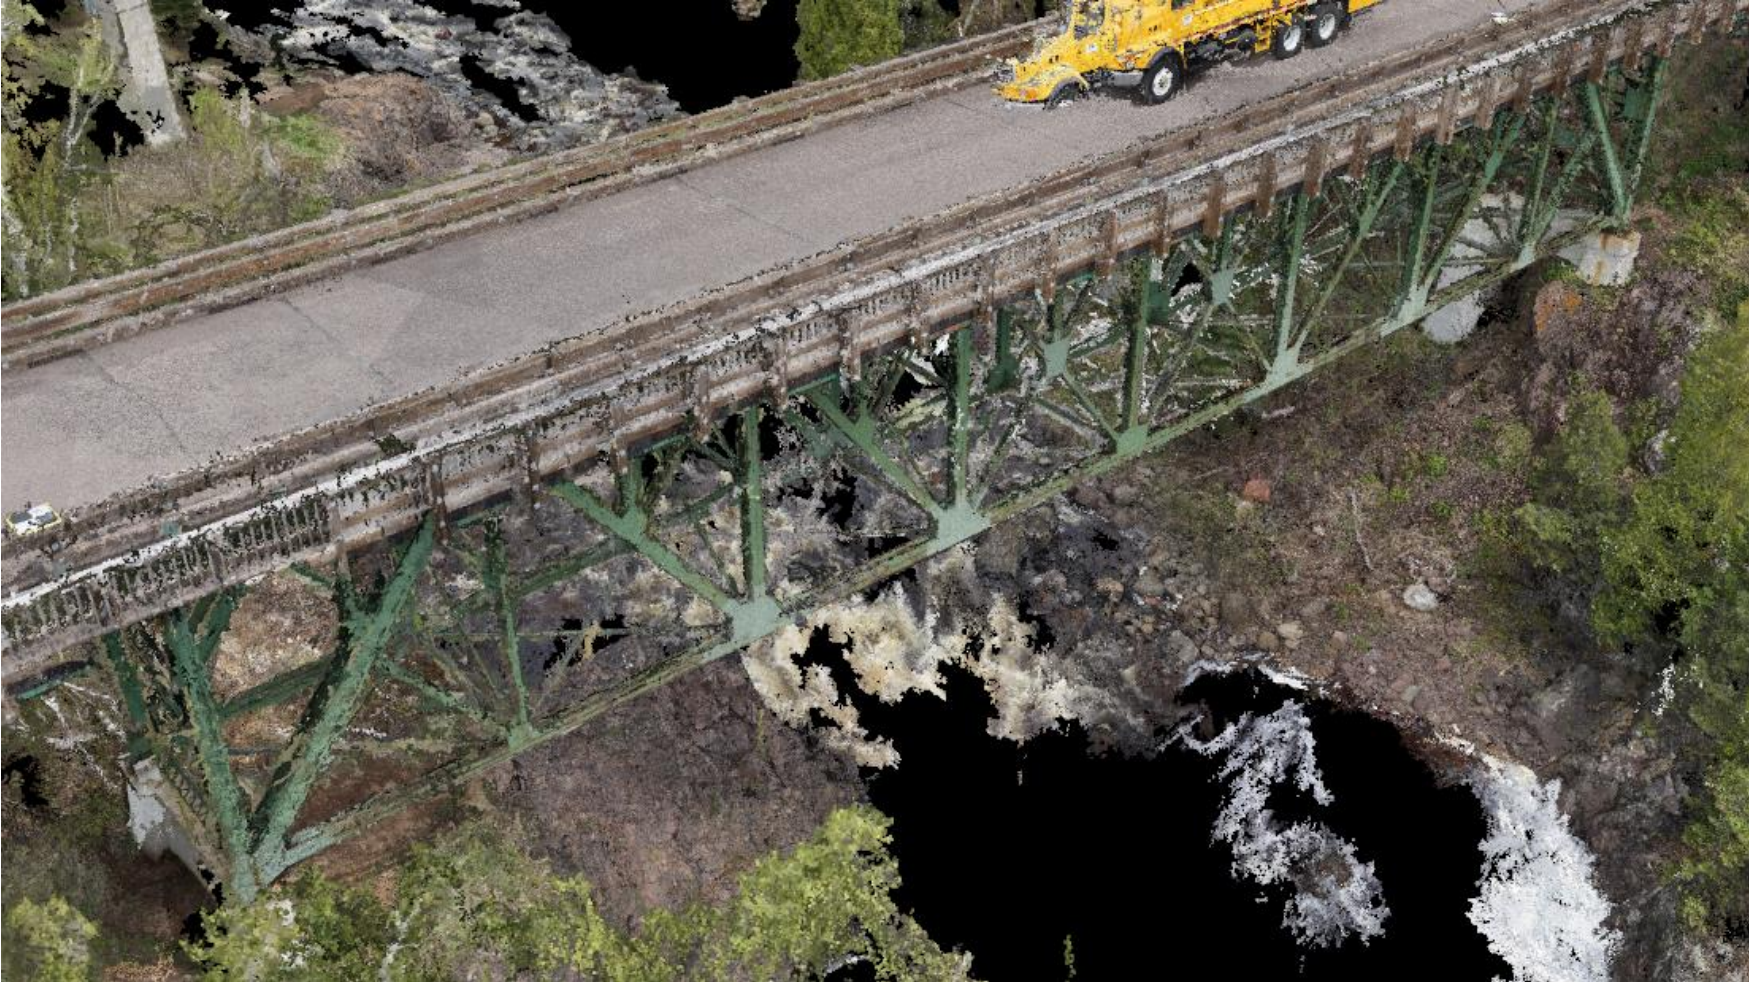
Deliverables – Point Clouds

3. Document Conditions and Deficiencies

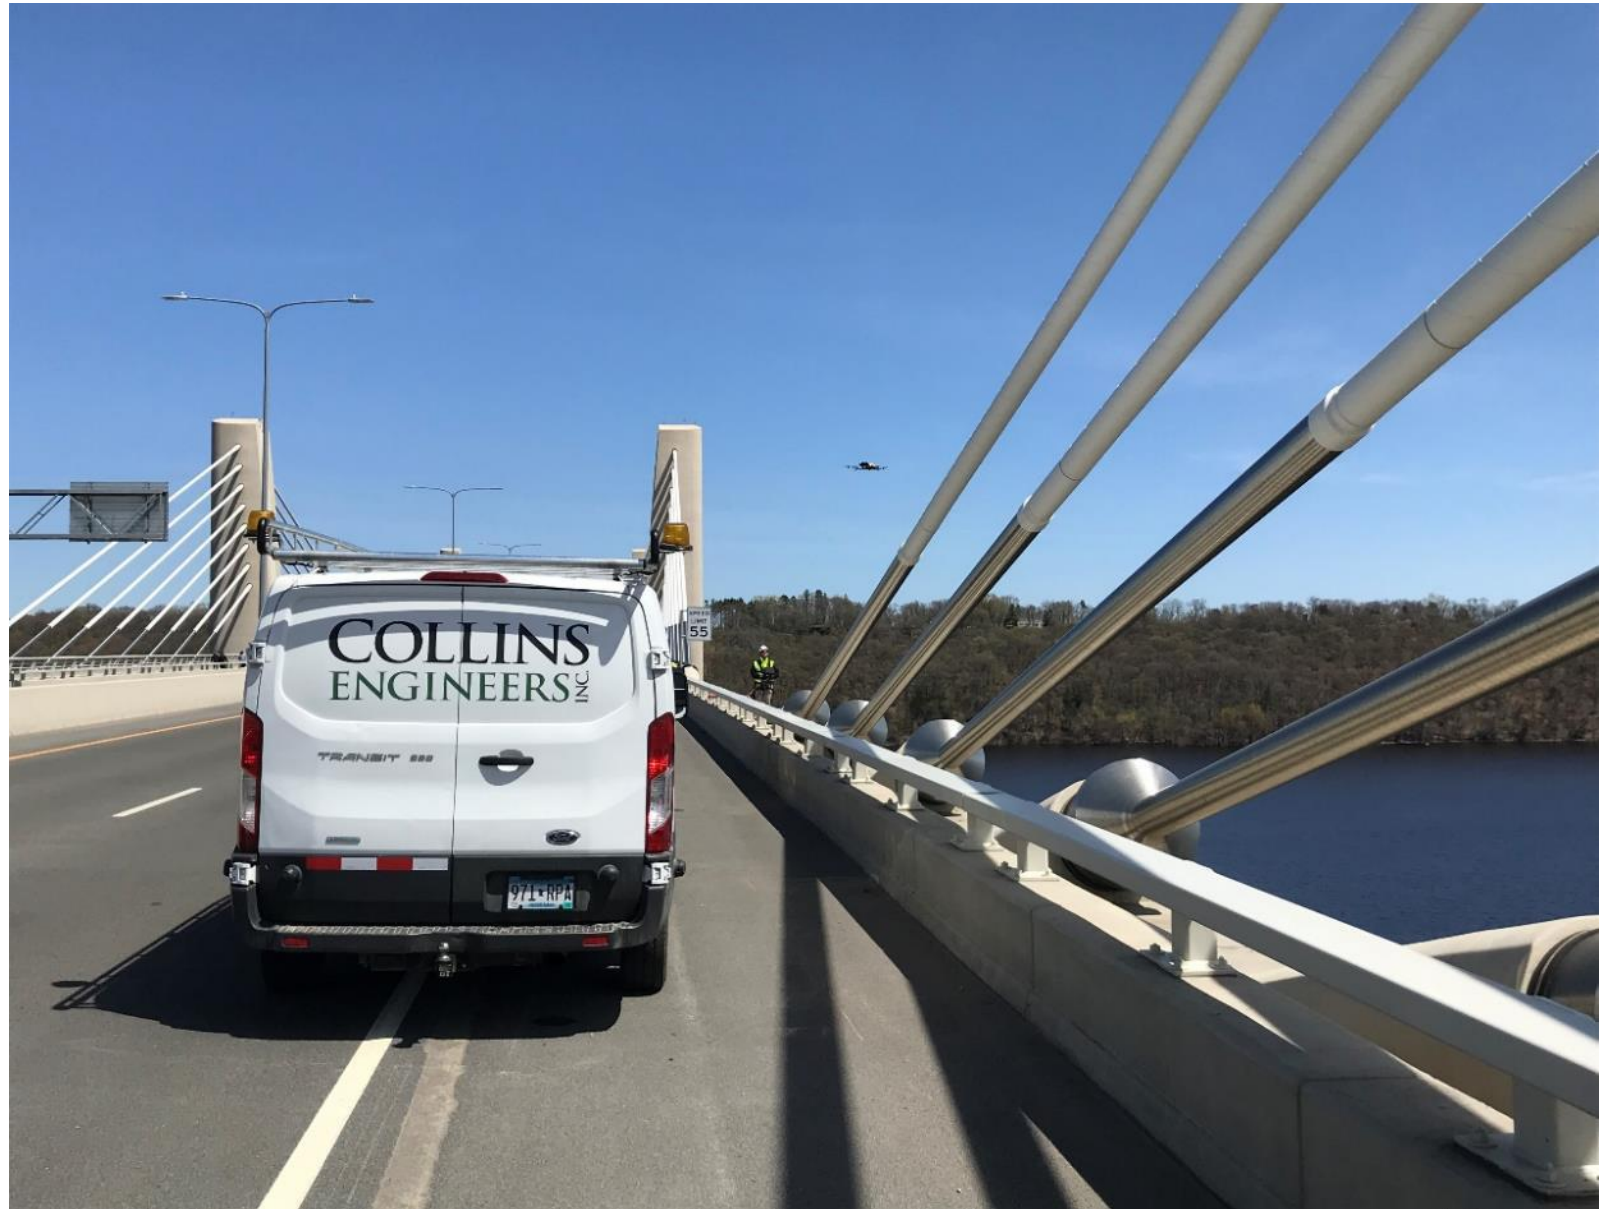
Deliverables

- 3D Models and High resolution photolog

The screenshot displays a software interface for inspecting a bridge pier. The main view on the left shows a 3D point cloud model of a concrete pier with a height measurement of 67.7493 ft. A blue line indicates the vertical axis, and a green 'X' marks a specific point on the pier. The interface includes a top navigation bar with a menu icon, a 'St Croix Pier' title, and buttons for 'FILES', 'DOWNLOAD', and 'SHARE'. On the right, a panel titled 'Inspection' shows a file ID 'DSC06263_1562084087000'. Below this, there is a section titled 'Protecting the Watershed' with text about the St. Croix River and a map of the watershed. A blue button labeled 'SAVE INSPECTION AS ANNOTATION' is visible, along with a message stating: 'We found 38 images matching the selected point of the model. They will be included in the inspection annotation.' The bottom right corner features the Minnesota Department of Transportation logo.

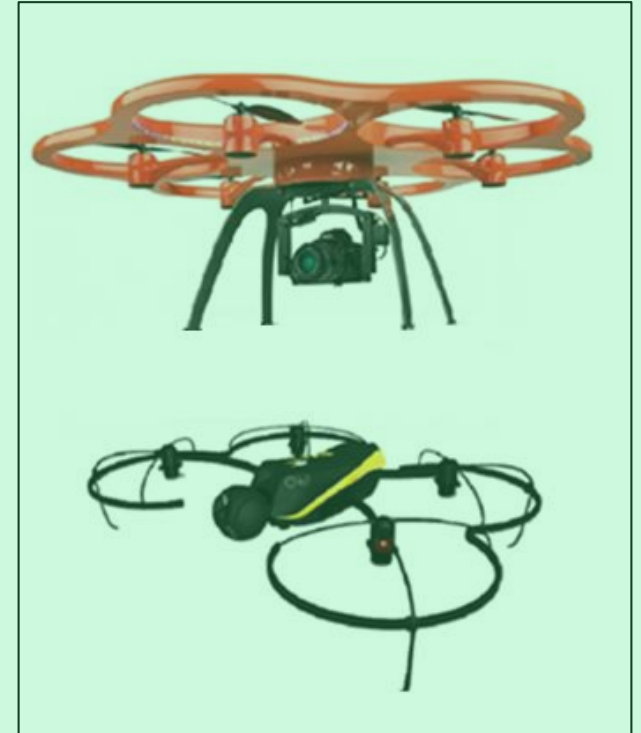
Multi-rotor

**Best option for
structural inspections**

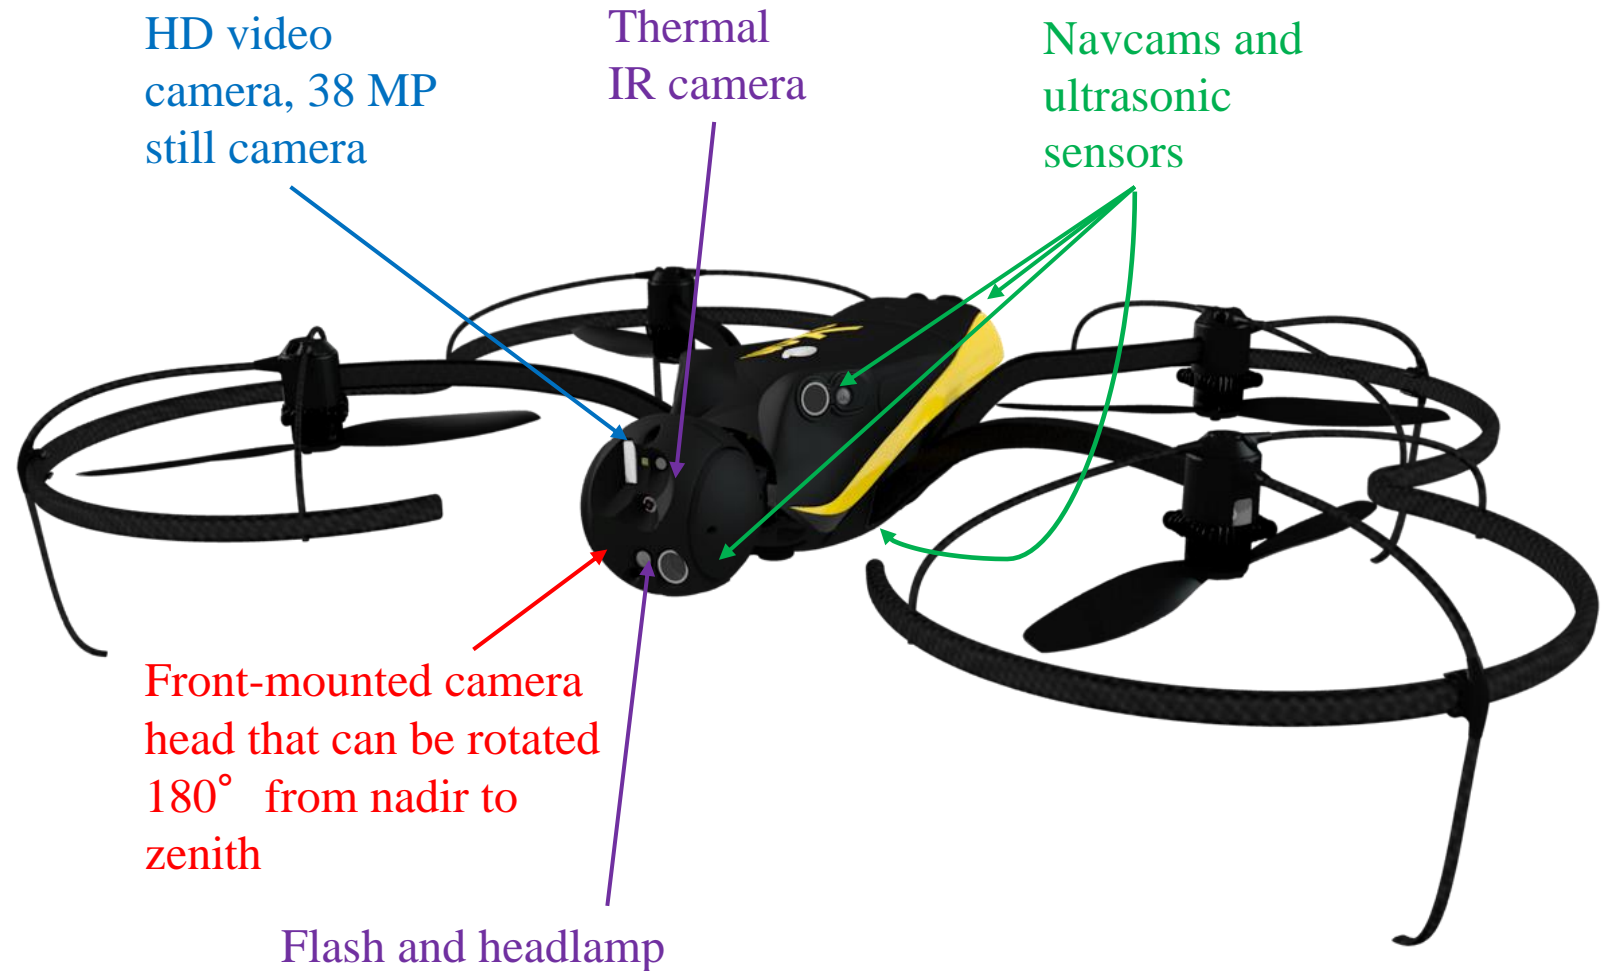
Components of a UAS Designed for Structural Inspections

Flight planning software designed to facilitate inspection projects

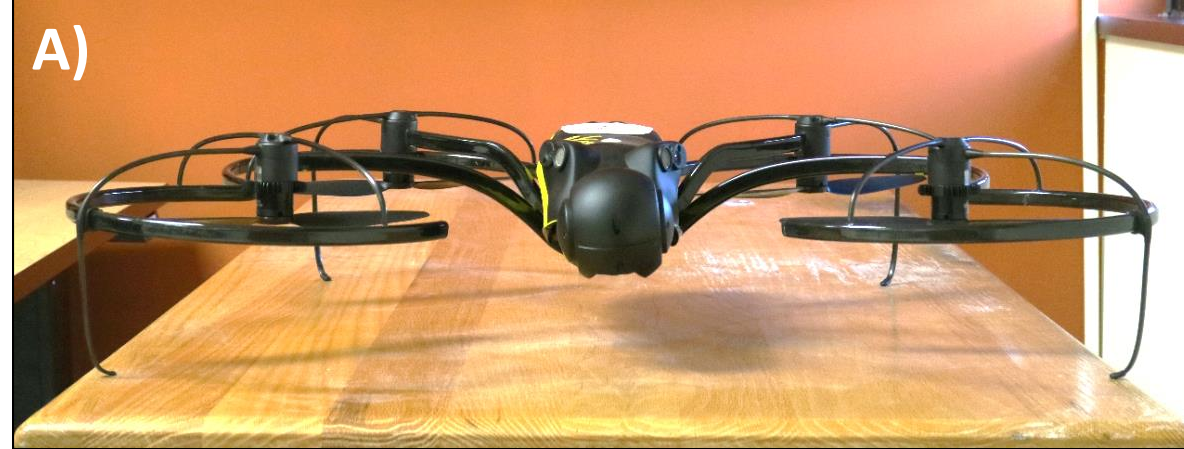
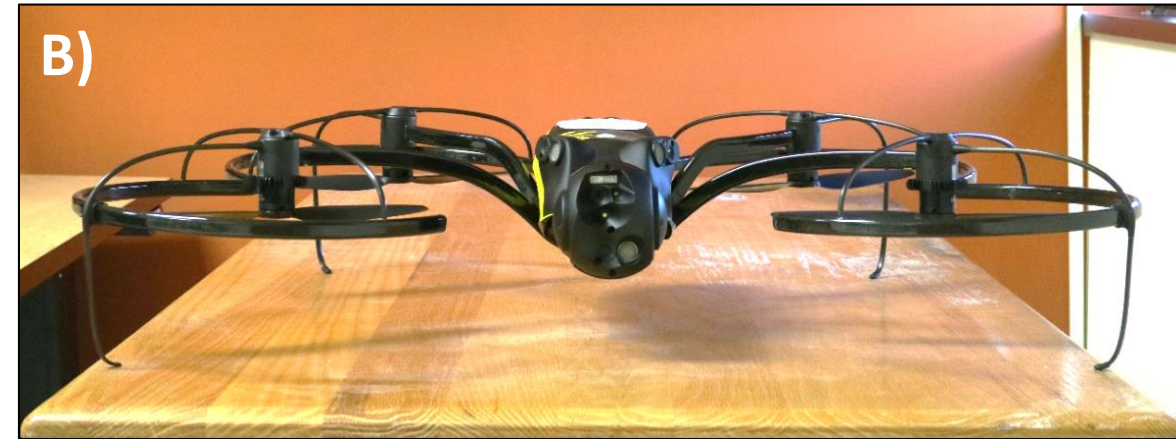
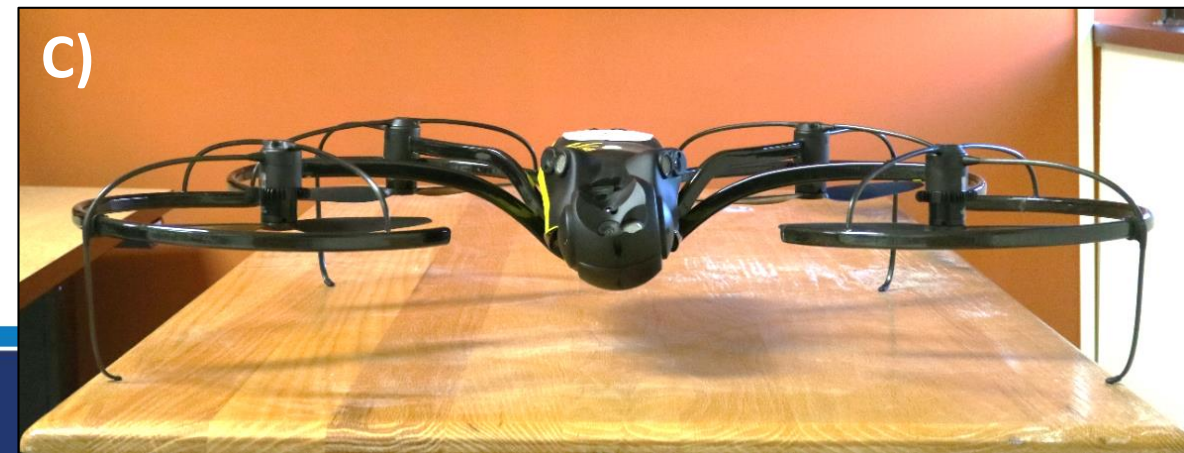
Importance of Rotating Sensor Head

A) Camera optical axis pointing down (nadir)

» Typical mapping configuration

B) Camera optical axis pointing horizontal

» Common in inspection work

C) Camera optical axis tilted up

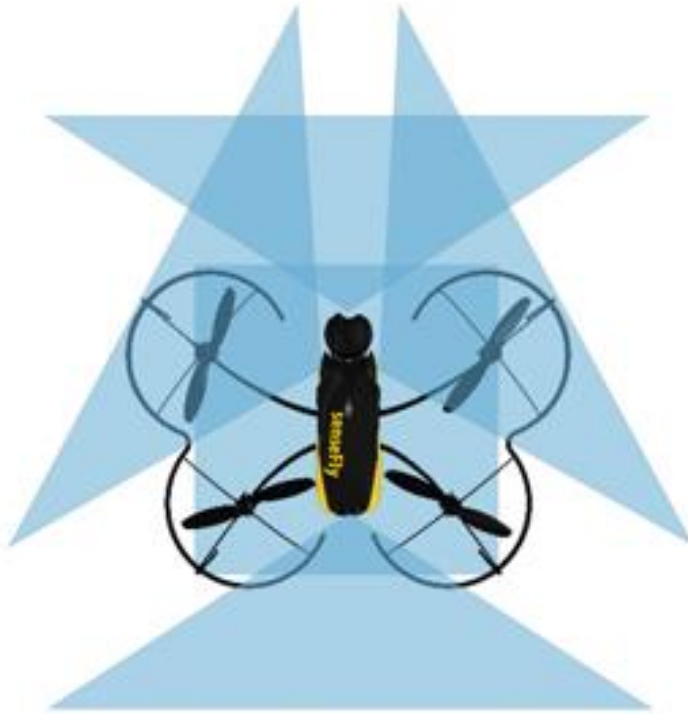
Navcams

Importance of NavCams & Obstacle Avoidance

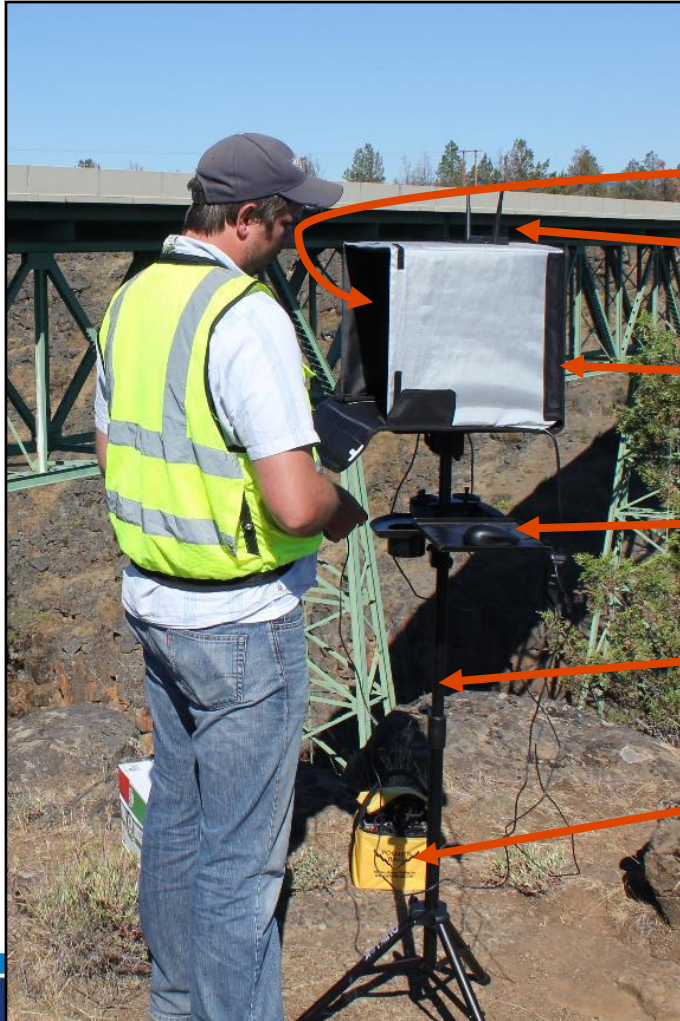
Ground Control Station

Laptop/Computer

Datalink Antenna

Sun-Shade

Various Trays

Portable Music Stand

Marine Battery

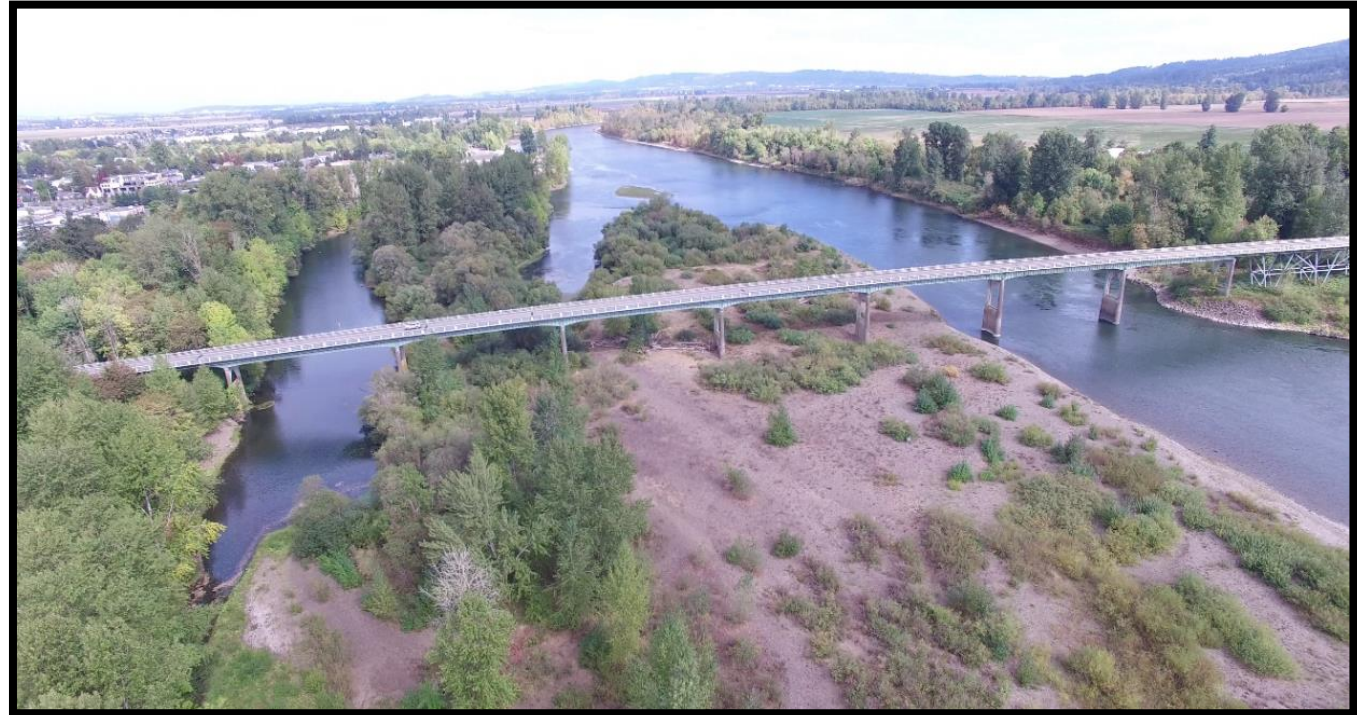
Test Bridge Inspection: Independence Bridge, Sept 2015

- Location: Independence, OR
- Airframe: Phantom 3 Pro
- Flight objective
 - » Test bridge inspection workflow
 - » Capture still and video imagery
- Details
 - » Large deck plate girder bridge
 - 675.4 m long
 - Longest span: 46.3 m
 - » Classified as Fracture Critical

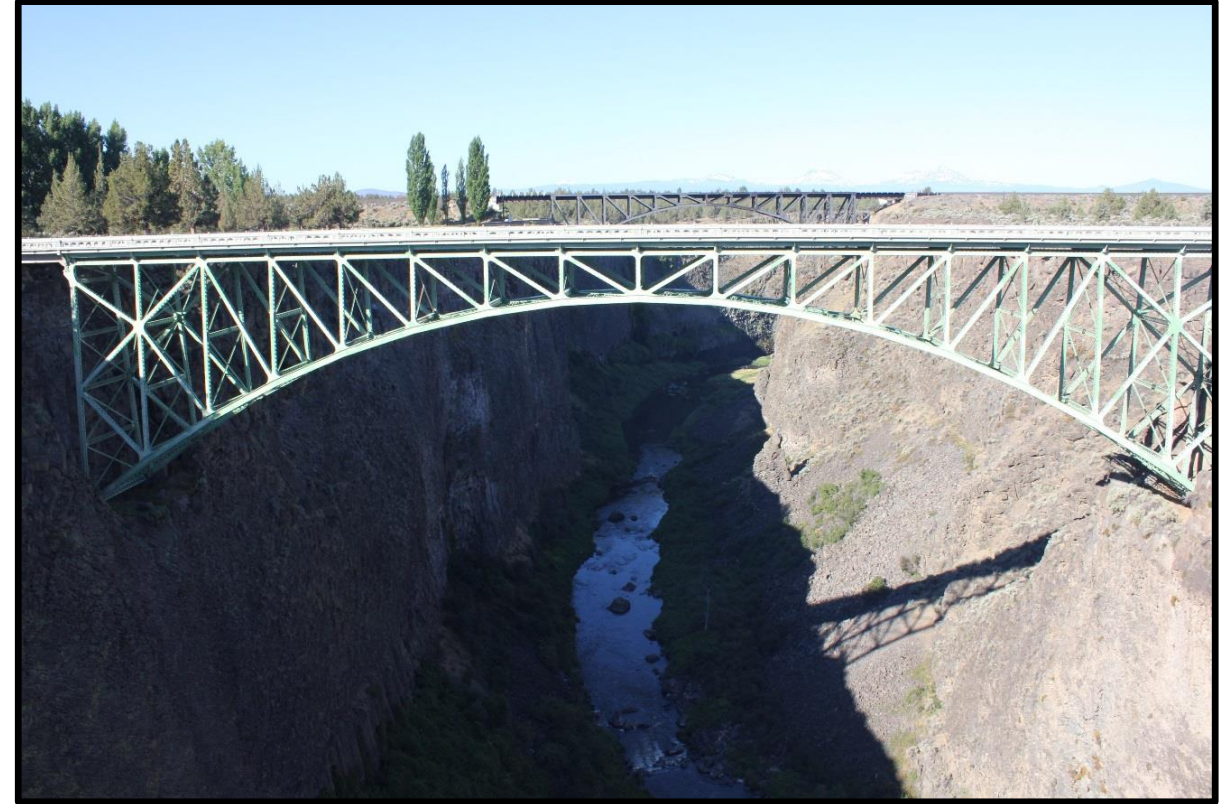
Test Bridge Inspection: Crooked River Bridge, July 2016

- Location: 8 km north of Terrebonne, OR
- Airframe: senseFly Albris
- Flight objective
 - » Capture high-quality imagery for inspection purposes
 - » Targeting specific areas that are difficult to inspect using traditional methods
 - » Create 3D model via SfM
- Details
 - » Steel Arch Bridge
 - » 141 m long
 - Longest span: 100 m
 - » Pedestrian only

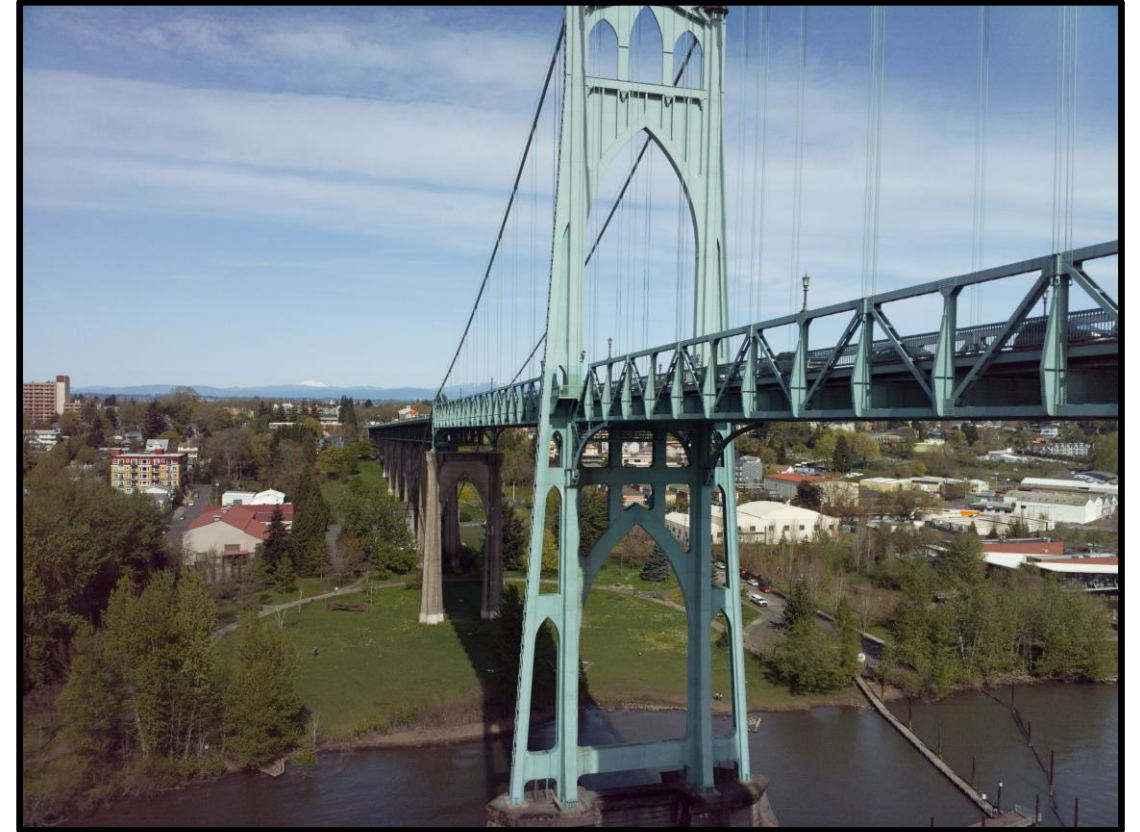
Test Bridge Inspection: St. Johns Bridge (Prelim Test), Sept 2016

- Location: Portland, OR
- Airframes: senseFly Albris, s900 with Sony WX500 (30x optical zoom)
- Flight objective
 - » Test of optical zoom camera
 - » Capture high-quality imagery
- Details
 - » Metal Riveted Warren deck truss
 - » Wire Cable Suspension
 - » 1100 m long
 - Longest span: 368 m
