Breakout Session Track 2: Structural Inspection

Structure Inspections Utilizing UAS

Improving Quality of Bridge Inspections Using Unmanned Aircraft Systems (UAS)

U s e o f U A S i n B r i d g e I n s p e c t i o n

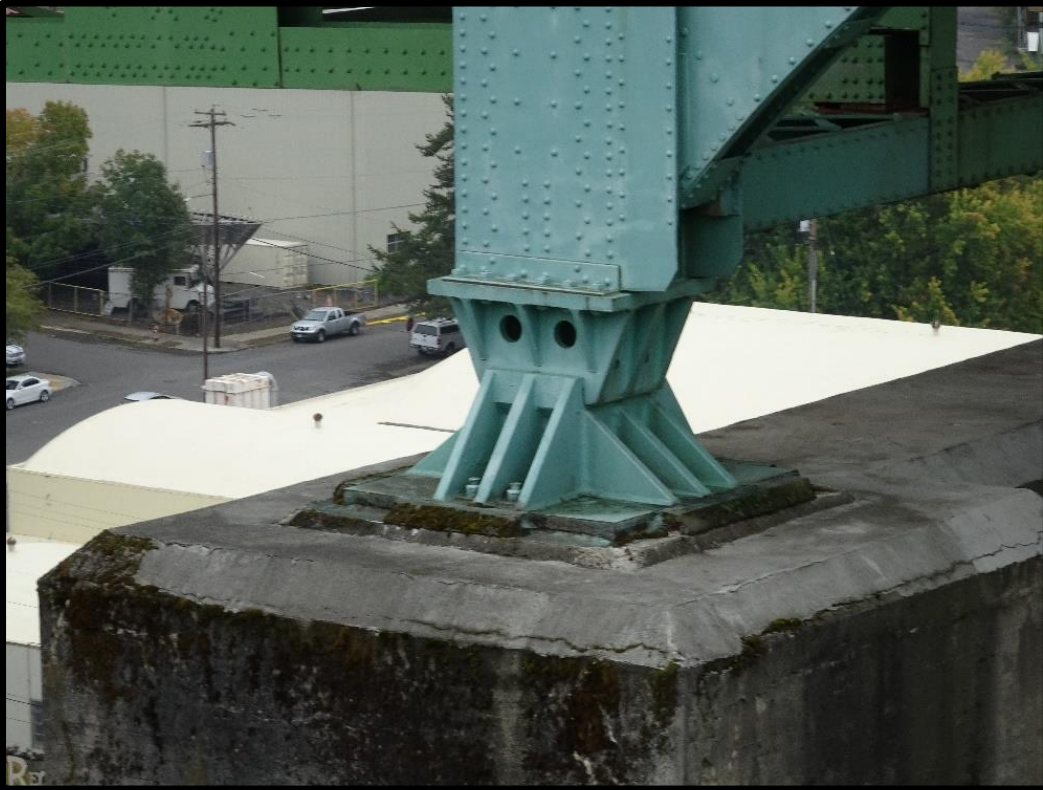
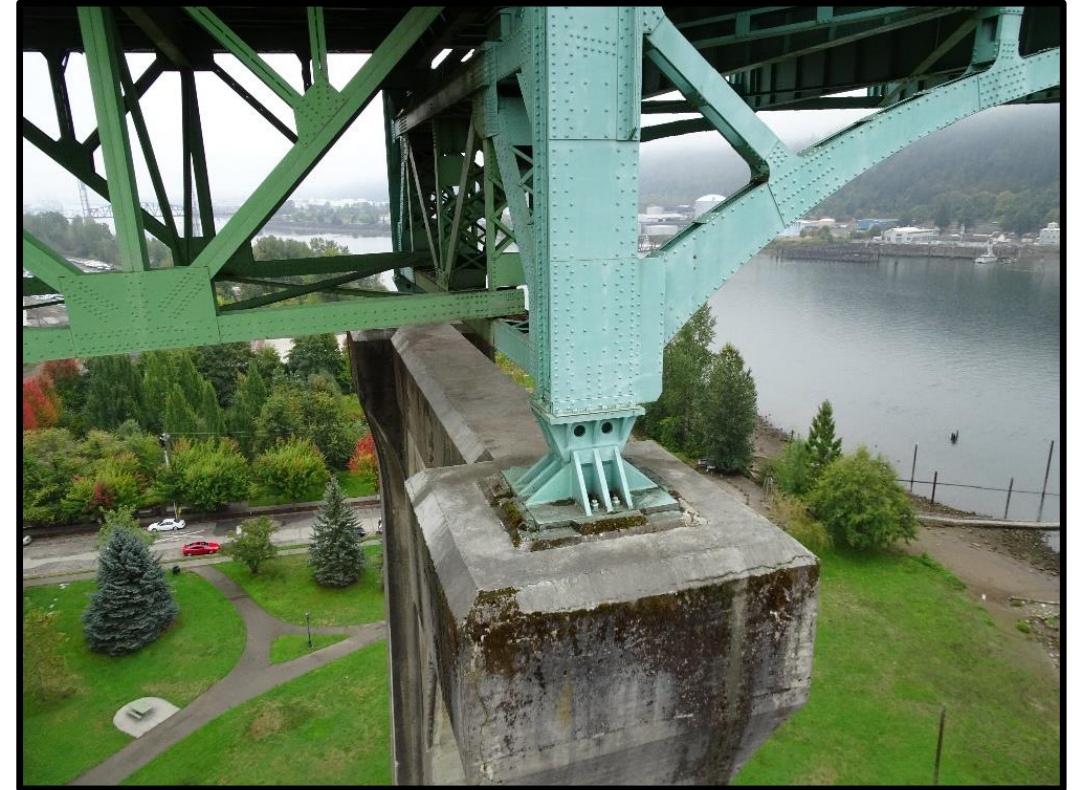
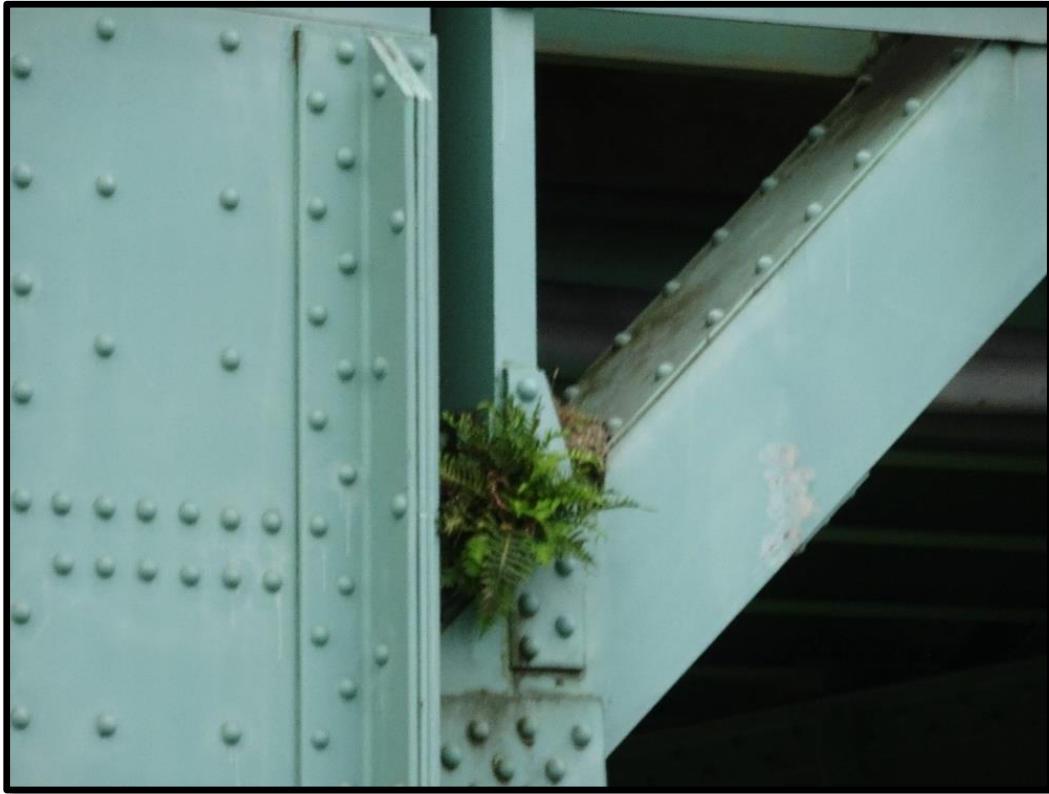
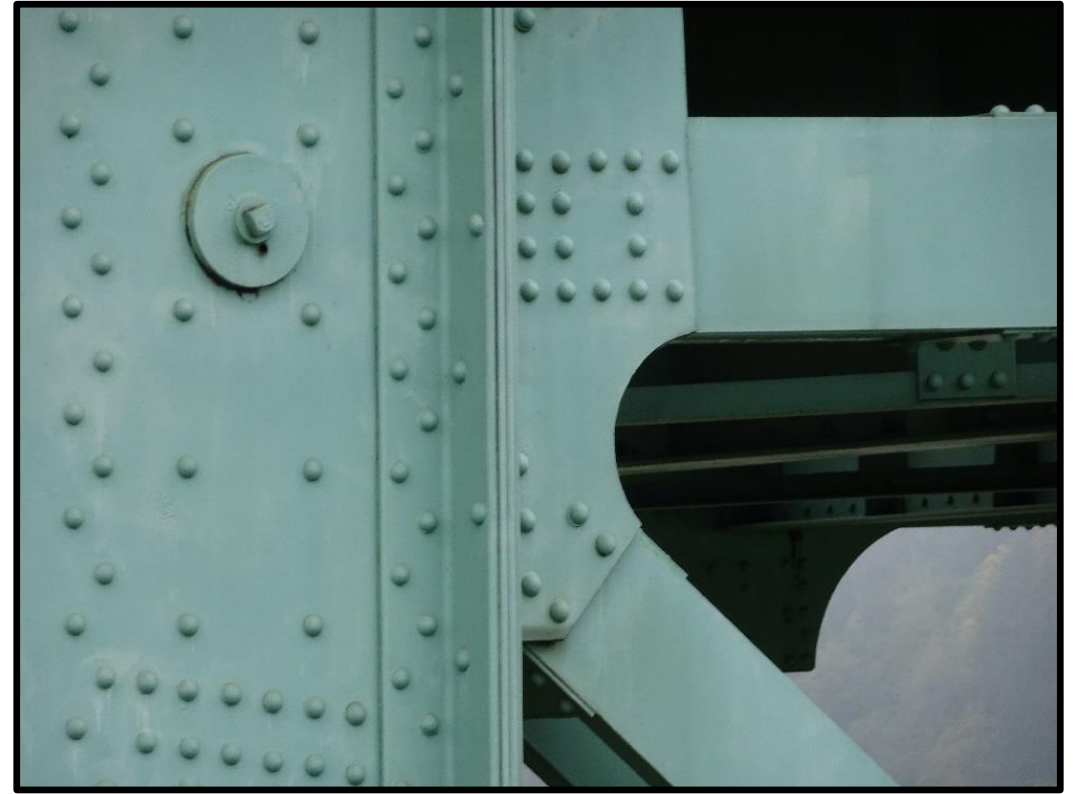
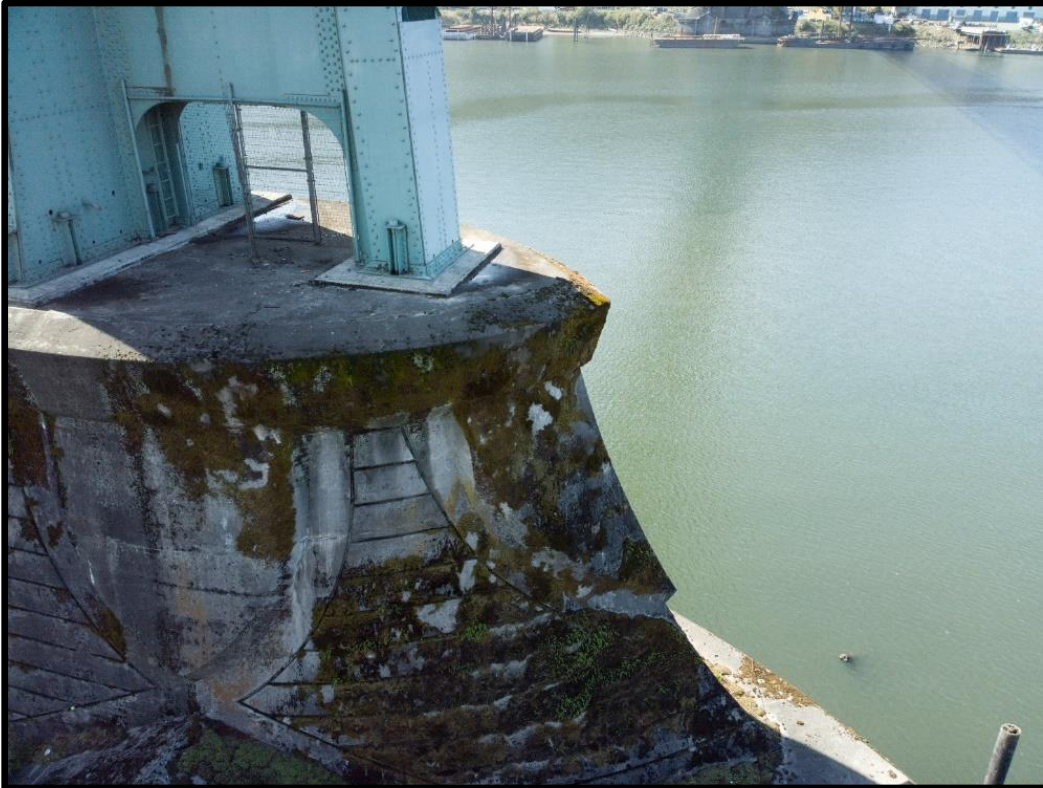
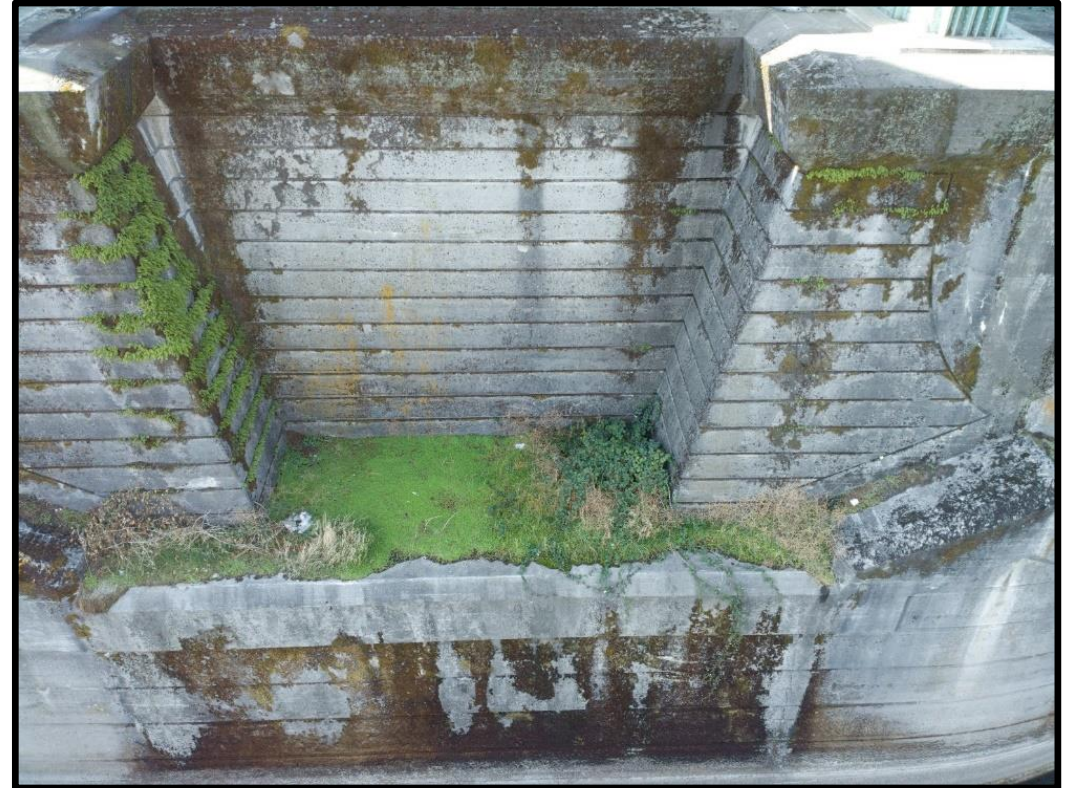
St. Johns Bridge: Imagery Examples

- Location: Portland, OR
- Airframes: senseFly Albris, s900 with Sony WX500 (30x optical zoom)
- Flight objective
 - » Test of optical zoom camera
 - » Capture high-quality imagery
- Details
 - » Metal Riveted Warren deck truss
 - » Wire Cable Suspension
 - » 1100 m long
 - Longest span: 368 m

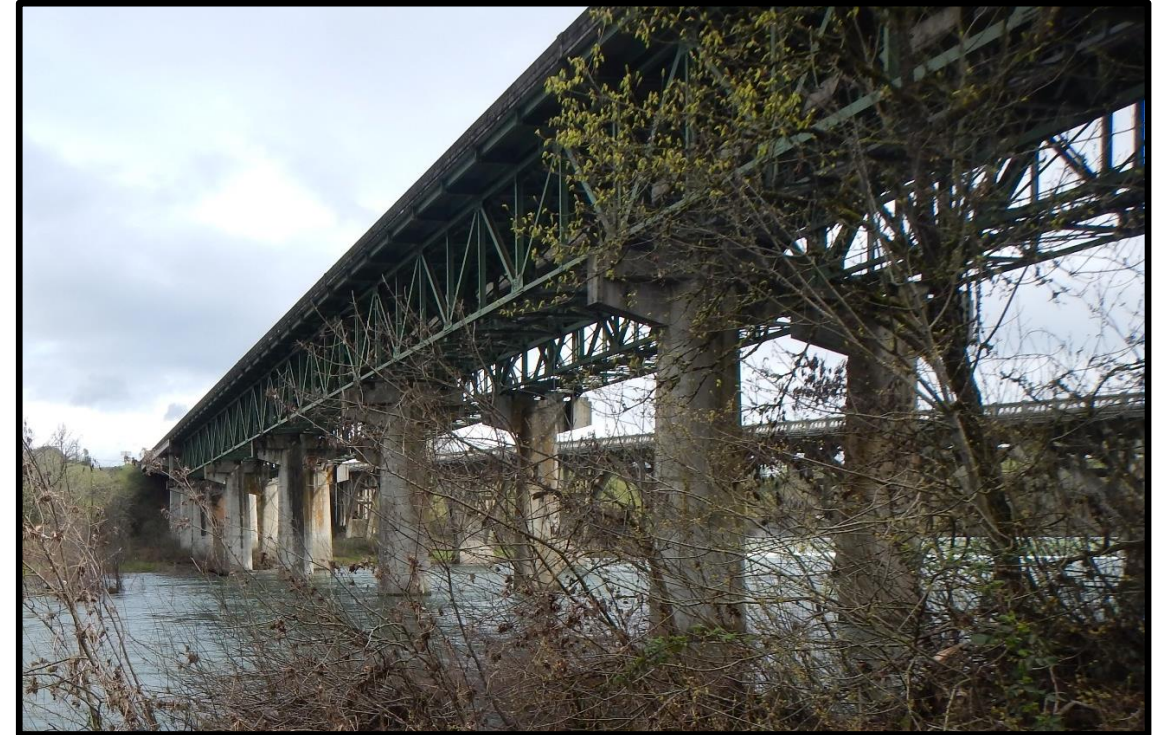
Test Bridge Inspection: Winchester Bridge, March 2017

- Location: Winchester, OR
- Airframes: senseFly Albris
- Flight objective
 - » Capture imagery while receiving real-time input from inspectors
- Details
 - » Warren deck truss bridge
 - » Southbound bridge of I-5
 - » 500 m long
 - Longest span: 42 m

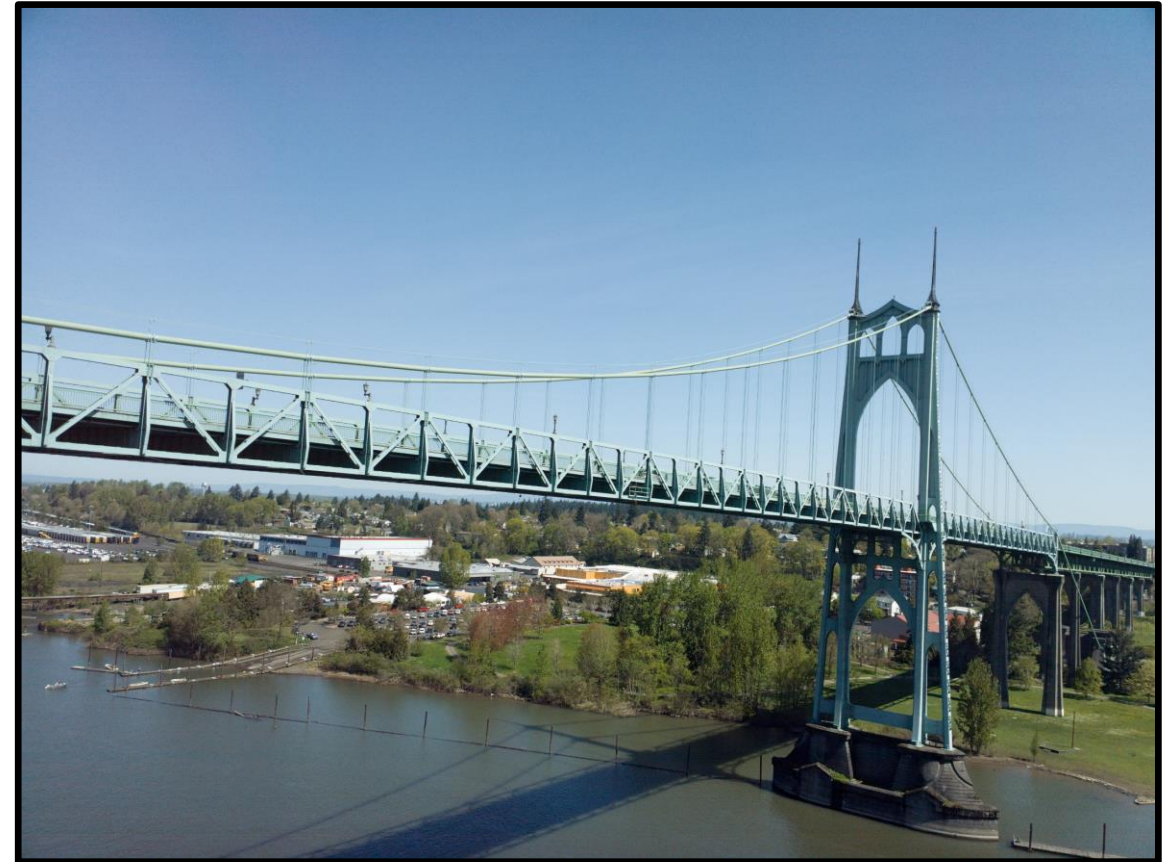
Test Bridge Inspection: St. Johns Bridge (Detailed Test), April 2017

- Location: Portland, OR
- Airframes: senseFly Albris
- Flight objective
 - » Week-long, in-depth inspection
 - » Test inspecting directly under deck
- Details
 - » Metal Riveted Warren deck truss
 - » Wire Cable Suspension
 - » 1100 m long
 - Longest span: 368 m
 - » Flight limited to eastern 550 m from center of main span

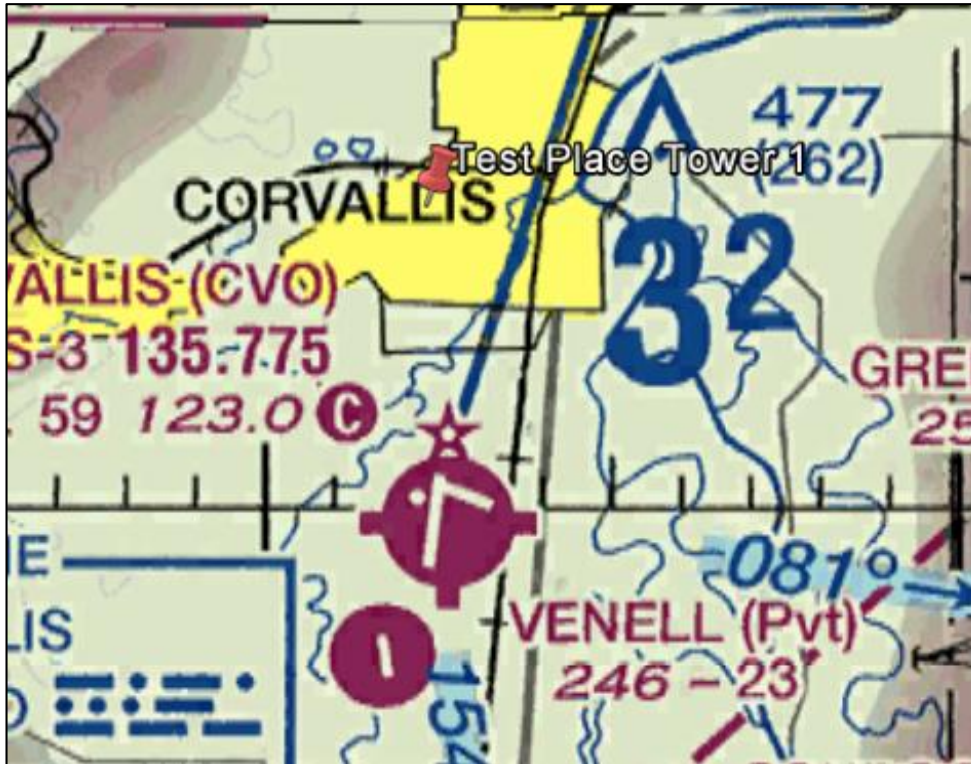
Safety Plan

Date of Assessment:	04/25/2016	Personnel:	Pilot in Command:	Tom Normandy
Structure Type:	Communication Tower		Primary Observer:	Matt Gillins
Location of Structure:	44°26'10.8" N 122°59'07.1" W		Other Spotters:	Farid Javadnejad Dan Gillins Chris Parrish
Owner of Structure:	ODOT			
Owner's Contact info:	555 13th St NE Salem, OR 97301-6867 Phone (503) 986-2700		COA Number:	2015-AHQ-105-COA-TS
			Team 's Emergency Contact Number:	(818)-497-8576
Airport within 5 nm?	Yes: X	No:	Airport Manager:	Jacob Kropf
If Yes Which:	J & J airport		Manger Contact info:	(541)-766-6783
Distance from Airport:	3.2 nm		Radio Frequency Air Traffic Controller:	N/A UNICOM 123.0

YES	NO	Equipment Hazards	YES	NO	Personal Hazards	YES	NO	Environmental Hazards
X		Nearby Vehicular Traffic		X	Twisting/Bending/Awkward Positions/ Heavy Lifting		X	Falling Debris
	X	Nearby Heavy Equipment Operations		X	Working Over water		X	Confined Space
	X	Transport/Launch of Boat/ATV/Etc.		X	Loose unstable footing	X		Weather Related
	X	Boat/Watercraft Operations	X		Slip/Trip/Fall Hazard	X		Live Stock/Wildlife
	X	ATV Operations		X	Ladders/Elevated Platforms	X		Transients
X		Other		X	Other		X	Other
